April 4, 2016

**Re: Walt Ranch Development Project Final EIR**

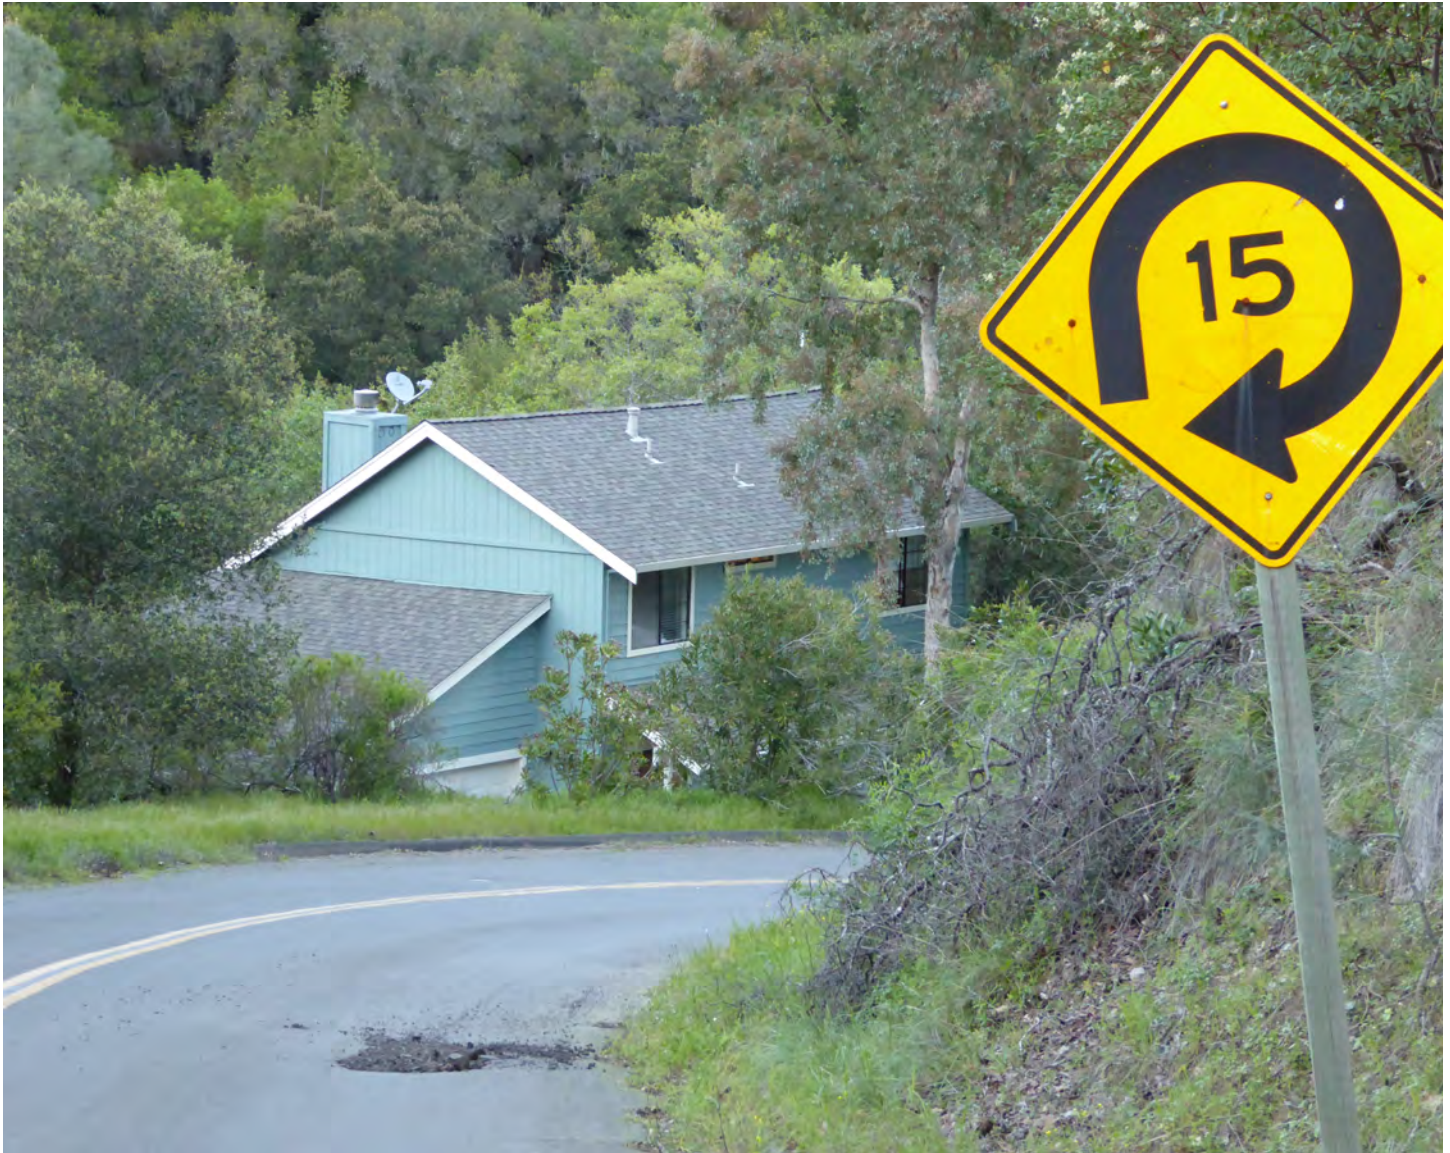
The FEIR is inadequate in its response to safety and stability questions about the proposed access point. Circle Oaks Drive is a residential road fitting the description of a “General Minor” road in the Napa County Road & Street Standards, 2016 revision (page 13) . With a grade of 18 percent and a sight-line on the s-curve of only 95 feet, it fails to meet two major design criteria: “maximum grade” and “minimum sight stopping distance”(page 19). A couple of basic questions arise that need to be addressed were the County to support this folly: 1) What is the stopping distances for construction vehicles and grape hauling trucks fully laden going down an 18% grade when the weight , braking, and driver reaction times are considered; and 2) How does this distance compare to a 95 foot sight line of pedestrians using the edge of the street where there is neither a sidewalk nor a proper shoulder?

I have attached a picture of the S-curve, which not only shows the nature of the somewhat blind curve, but also road damage that appeared with a recent 10 day period of heavy rain that totaled 13 inches.

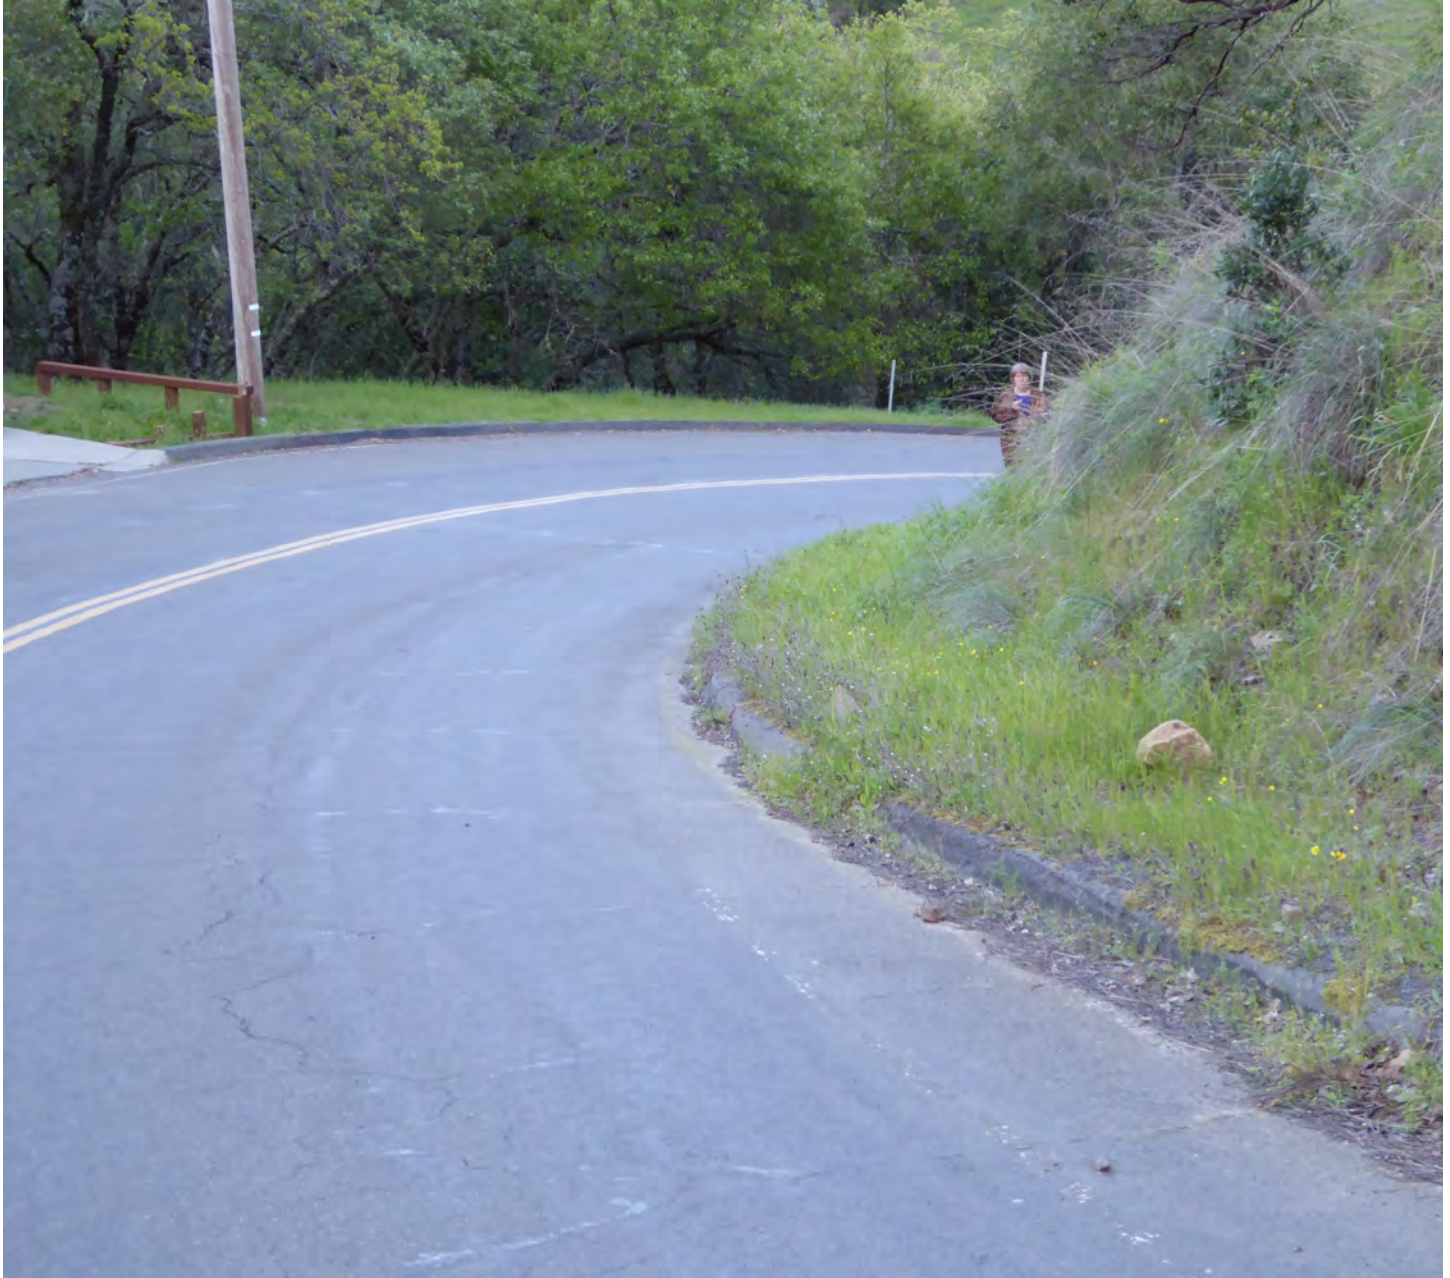
A second picture shows what a pedestrian would look like to a truck driver going down the slope 95 feet from the individual, the distance at which a pedestrian would first appear to a careful driver whose eyes were fixed on the road ahead. It is important to acknowledge that drivers of grape harvest vehicles are paid NOT BY THE HOUR, but by the weight and number of trips. No reasonable person should expect that a suggested 15 mph speed will be observed.

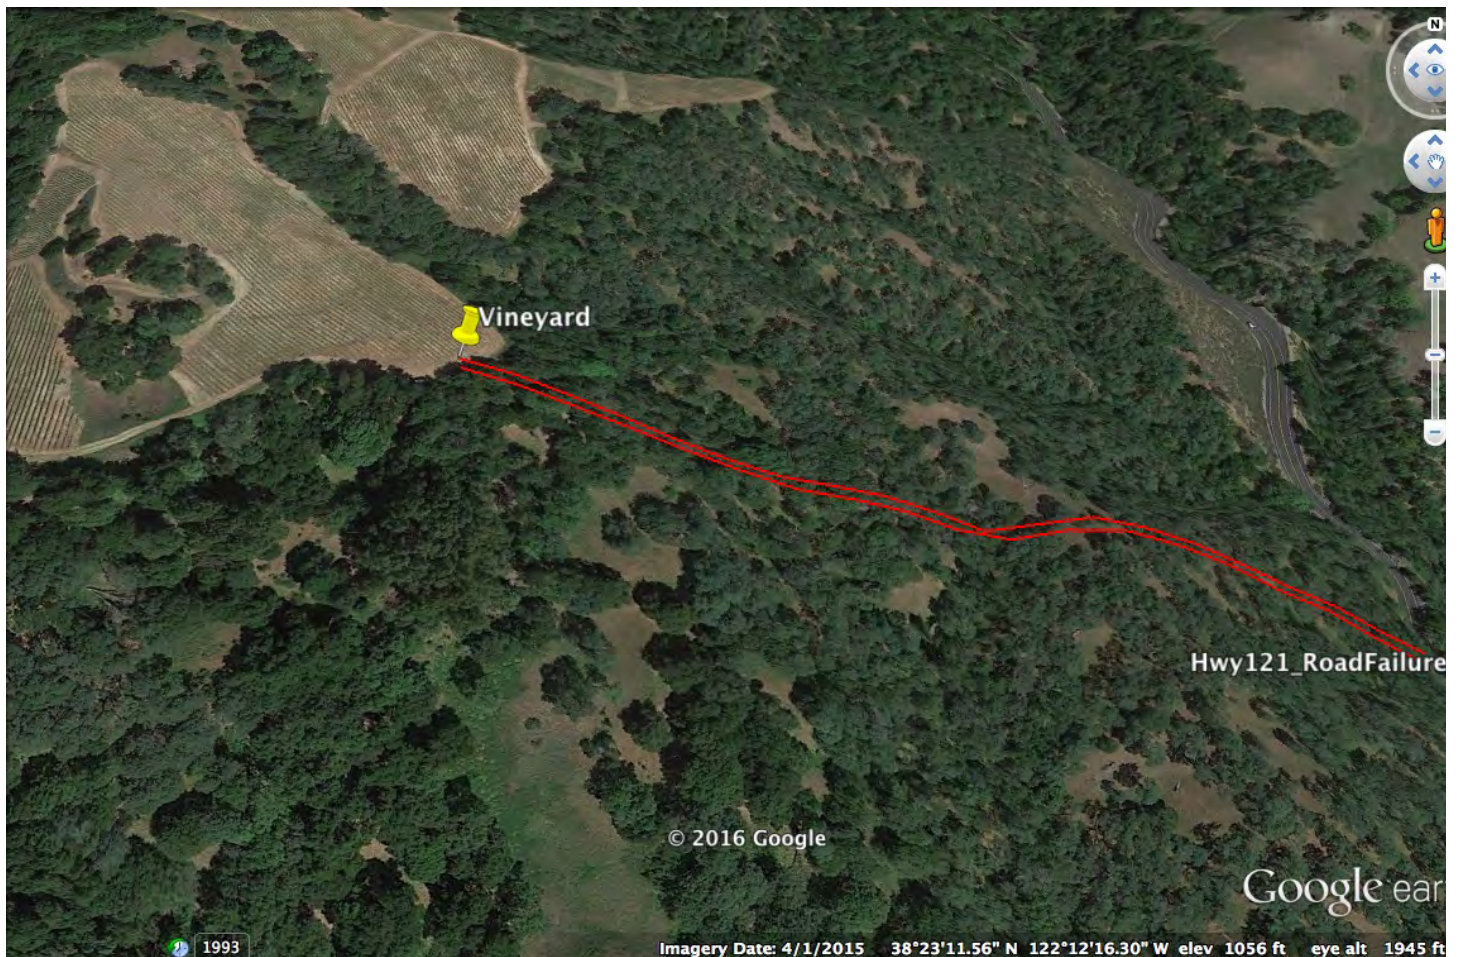
I have attached a graphic I created of the March 2016 road failure on Hwy 121 located 1 ½ miles south of Circle Oaks. The big question is what role the vineyard located 400 yards from the road loss contributed to this multi-million dollar repair project. The washout occurred because of an accumulation of water on the western (vineyard) side of the road (NOT from the creek below UNDERcutting the road, as has occurred in the past). There is a swale that begins far above, and deposited the water right at the location of the road failure. The vineyard above that undoubtedly contributes water to this flow is planted in a downhill direction that appears to intensify water runoff. Where is the directionality of vineyard planting discussed in the Walt Ranch FEIR? This is the very risk faced by the Circle Oaks community, with similar slope and similar soil.
